Performance Characteristics of the Atlas 60 KV, 60 KJ Plastic Capacitors

W. Reass, G. Bennet, D. Bowman, E. Lopez, M. Monroe, and W. Parsons
Los Alamos National Lab
P.O. Box 1663, Los Alamos, NM 87544

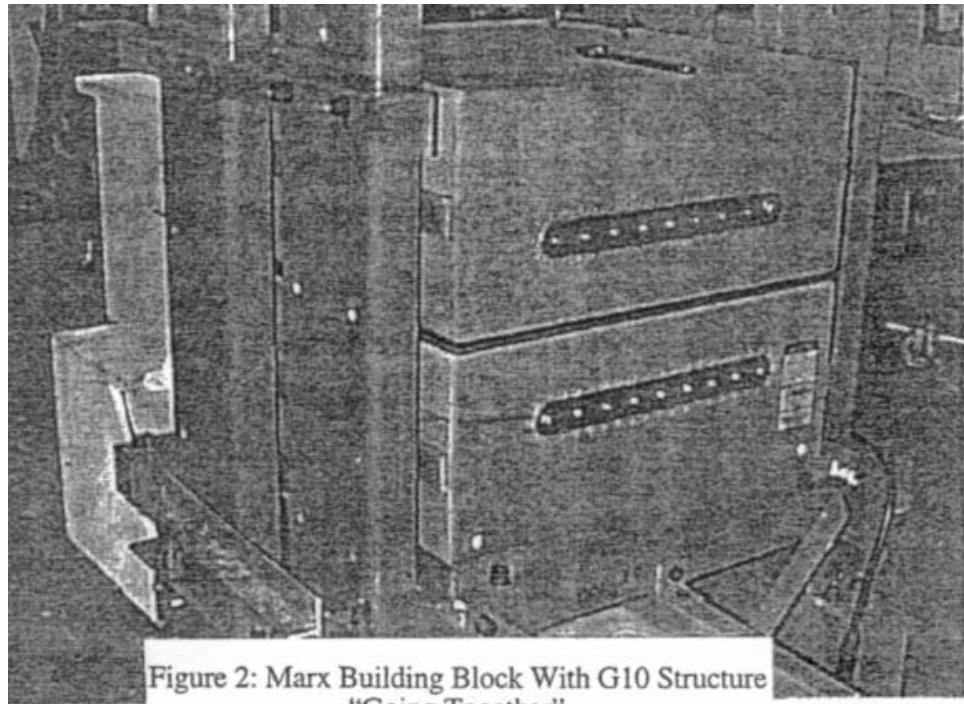
Figure 2: Marx Building Block With G10 Structure
"Going Together"

For the capacitor evaluations, the Atlas Marx modules are assembled into a G10 support structure as shown in Figure 2. Wheels are provided to slide the Marx module into and out of our electrically and acoustically shielded test vaults (as shown in Figure 3). The test waveforms are digitized and stored for further analysis if required. The primary test intent is determine the capacitor lifetime statistics and develop railgap maintenance procedures. Two charge time intervals have been used for the capacitor testing. A 12 second charge time (for the capacitors evaluated in this report) and more recently, a 28 second charge time. The different charge times have been used to evaluate railgap prefire statistics as related to charging duration. A longer charge time would be beneficial to reduce power supply and utility installation costs. There is no appreciable hang time (~1s) before the capacitors are discharged. An added plus of our capacitor test program has enabled us to evaluate and modify railgap maintenance procedures that minimize prefires. The new maintenance procedure has extended the railgap re-build interval to over 160 shots.
